Technical BULLETIN

SAFETY RECALL

CERTAIN 2021 AND 2022 PROGRAM YEAR VF200LB, VF200XB, VF225LB, VF250LB, AND VF250XB OUTBOARD MOTORS FACTORY MODIFICATION CAMPAIGN – Ignition Control Software Update

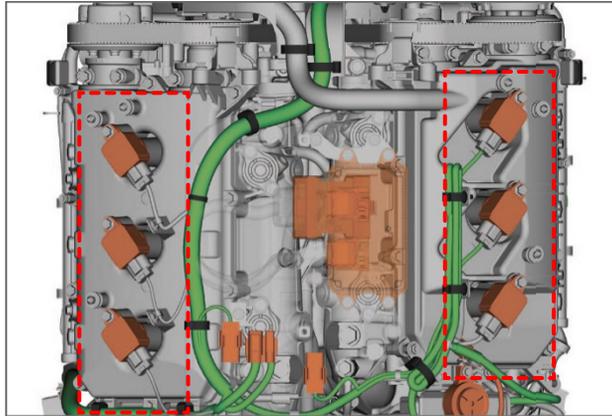
Before starting the procedure, turn off the battery switch(es) or disconnect the battery(ies), and then disconnect the ignition coil couplers (6 pieces). Do not operate the power trim and tilt switch.

1. Turn off the battery switch(es) or disconnect the battery(ies).
2. Remove the top cowling, flywheel cover, and ignition coil cover.
3. Disconnect the ignition coil couplers (6 pieces).

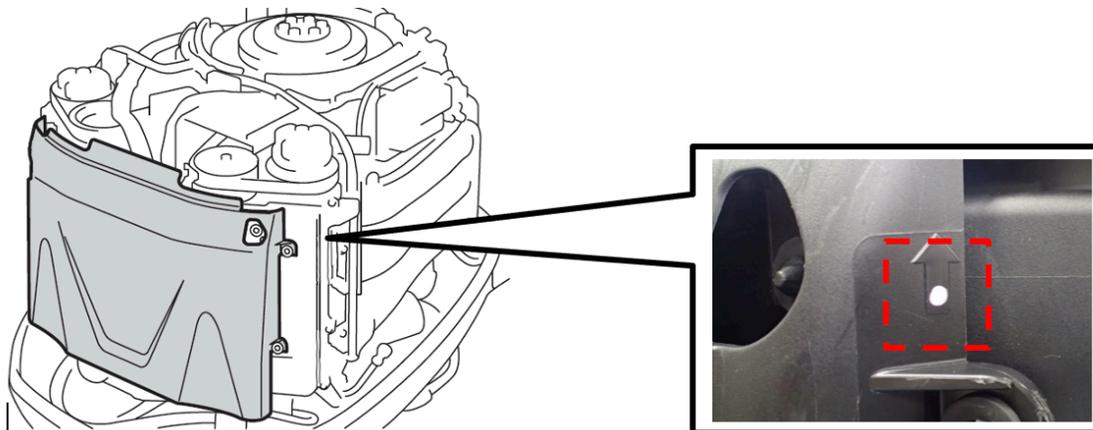
Before beginning work on an unfamiliar outboard motor, remove the top cowling. The presence of the white mark on the ignition coil cover as shown above is an identification that this corrective action has already been performed.

After completing the reprogramming, put a white paint mark on the ignition coil cover as shown below.
