Technical BULLETIN

SAFETY RECALL

CERTAIN 2021 AND 2022 PROGRAM YEAR VF200LB, VF200XB, VF225LB, VF250LB, AND VF250XB OUTBOARD MOTORS FACTORY MODIFICATION CAMPAIGN – Ignition Control Software Update

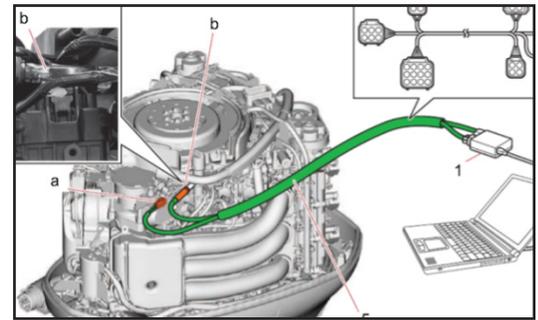
Yamaha Motor Corporation, U.S.A. has decided that a defect that relates to safety may exist in certain 2021 and 2022 program year VF200LB, VF200XB, VF225LB, VF250LB, and VF250XB outboard motors. In affected motors, the ignition coils may be energized while the main switch is turned on or, on certain models, may even be energized by power trim and tilt switch operation with the main switch off. This is due to faulty engine control unit (ECU) software programming. If this happens, it could cause an ignition spark that might ignite unburned fuel inside the combustion chamber, possibly damaging the intake and manifold, while also increasing the risk of fire.

To correct this defect, Yamaha is initiating a Factory Modification Campaign. Affected motors must have the ECM software updated and a new program version identification sticker applied.
